## ROSS ENVIRONMENTAL ASSOCIATES, INC.

RE: *Supply Well Inspection/Sensitive Receptor Survey - Judd Residence*  
*5141 Nelson Hill Road, Derby, Vermont (SMS# 2012-4280)*

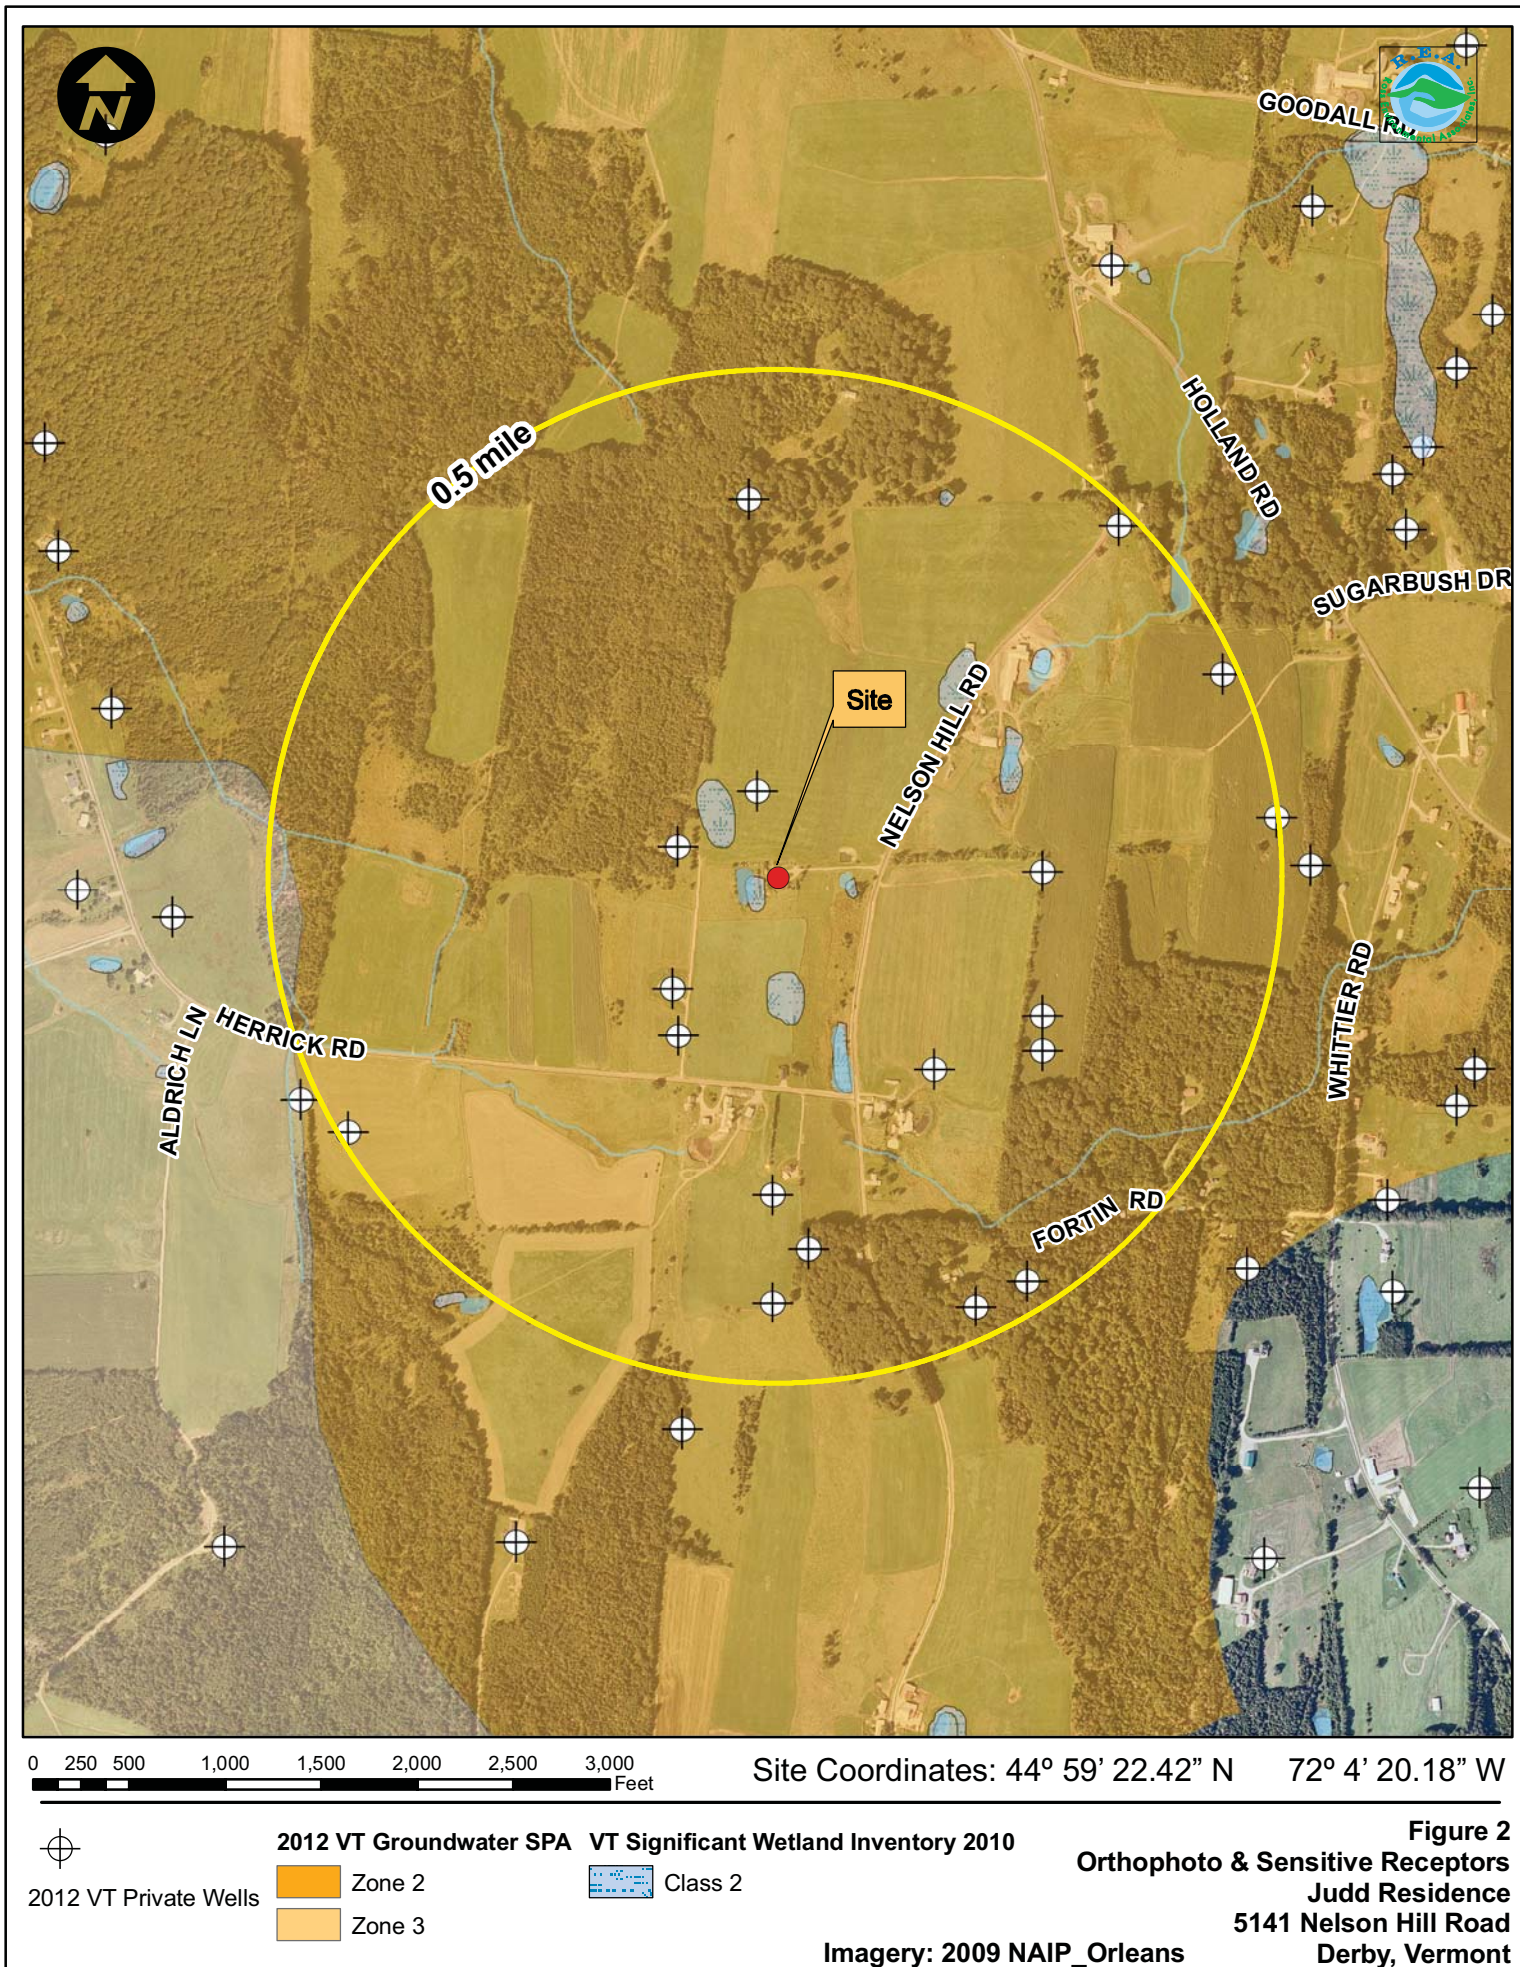
**Figure 3**  
**Site Plan**  
**Judd Residence**  
**5141 Nelson Hill Road**  
**Derby, Vermont**

The Judd Residence is located at 5141 Nelson Hill Road in Derby, Vermont (**Figures 1 & 2 Attachment A**). The property encompasses approximately six acres. The house is constructed with a poured concrete basement and an attached two-bay garage. The former above ground storage tank (AST) was located approximately 75 feet southeast of the house adjacent to a storage shed and detached garage. The former UST, which was removed in June 2012, was located approximately five feet off the southeastern corner of the house. The Judd's also own the abutting property (approximately 30 acres) to the north, which is open farm land occupied by a windmill. The surrounding land use is predominantly farm and residential. The site layout and significant site features are shown on **Figure 3, Attachment A**.

Drinking water for the site is provided by an on-site private well, which is located adjacent to the backside of the house approximately 110 feet north of the former AST. Based on review of the Well Completion report (Well Tag # 28438), the Judd well is reported to be approximately 295 feet deep with an estimated yield of three gallons per minute (gpm). The Well Completion report also indicates that the overburden is approximately ten feet thick and that the casing was extended to approximately twenty feet below ground surface. The on-site supply well has been impacted by petroleum contamination, which appears to be related to the AST spill and not from the use of the former fuel-oil UST that was removed in June 2012.

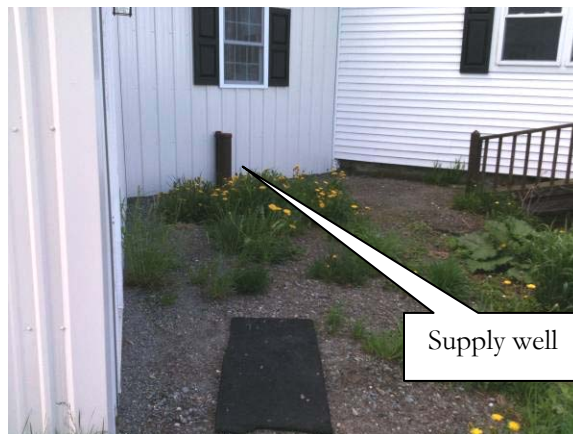
- Video inspection of the on-site supply well identified the likely point of contaminant entry to be at the drive shoe-bedrock interface, which is located approximately 20 feet below ground surface. Water seepage and staining was noted at the drive shoe.

On 7 August 2012, a video inspection of the supply well serving the Judd residence was performed by Gosselin Water Wells of Derby, Vermont under the supervision of an **R.E.A.** Field Scientist. Review of the video tape identified a small amount of water seeping into the well at the drive shoe, which exhibited signs of staining. Several fractures were noted in the well, but no staining was associated with any of the deeper fractures. Based on this information and the fact that only 20 feet

of casing was installed when the well was originally installed, the likely point of entry of the gasoline contamination is at the drive shoe-bedrock interface.

Photograph 2. On-site Supply Well. – View toward south.

2. The existing supply well should be replaced with a new supply well that is constructed to prevent contaminant migration from the upper bedrock formation and/or along the well casing. At a minimum, 60 feet of well casing should be grouted into the upper bedrock formation. At this time **R.E.A.** anticipates that the total depth of the new well will be approximately 300 feet; however, the actual depth will depend on site specific conditions at the time of installation.

5. The impacted supply well should be properly abandoned in accordance with VT DEC Water Supply Rules after the replacement well has been cleared for permanent use.

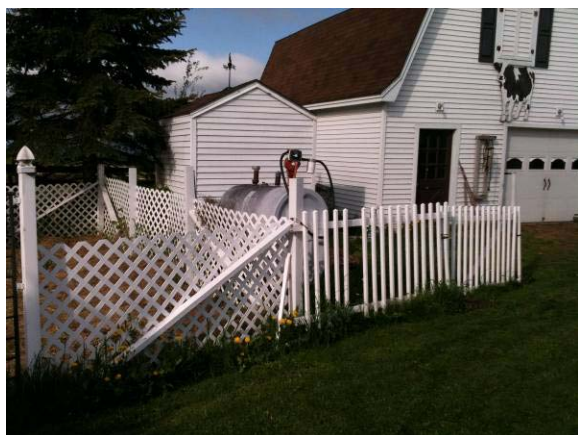
Based on review of the information collected to date, the likely source of petroleum contamination impacting the Judd's on-site supply well is the gasoline spill associated with the former AST system. Residual contamination from the area of the surface spill appears to have migrated within the upper bedrock formation, either along the bedrock surface or within the upper zone of highly weathered bedrock, and entered the on-site well along the drive shoe at the bottom of the casing. Deeper fractures were noted during video inspection of the supply well; however, no obvious signs of contaminant entry were noted at the deeper fractures. In addition, no petroleum contamination was indentified in any of the off-site supply wells sampled as part of this investigation, which suggests that contamination is likely limited to the Judd property. Based on this information, it is possible that a new replacement supply well can be successfully installed on site; however, no absolute guarantee can be made due to the nature of the spill and presence of residual contamination.

Photograph 3. Area of former AST – View toward south.

1. Prior to installation of a replacement well, the area of the proposed well should be investigated to insure the area has not been impacted by the spill. Soil in this area should be excavated to the top of bedrock and screened in the field for the possible presence of volatile organic compounds (VOCs) using a photo-ionization detector (PID).

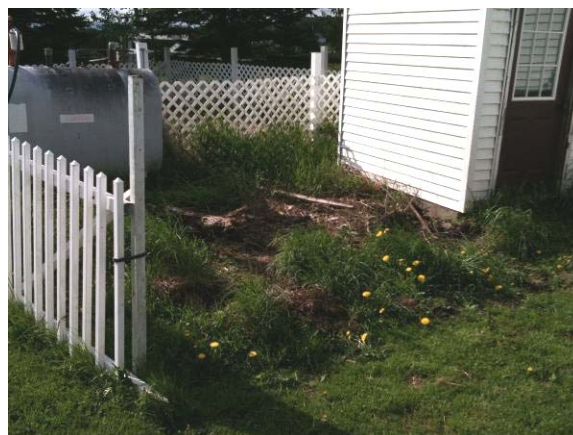
Photograph 4. Area of former AST – View toward southeast.

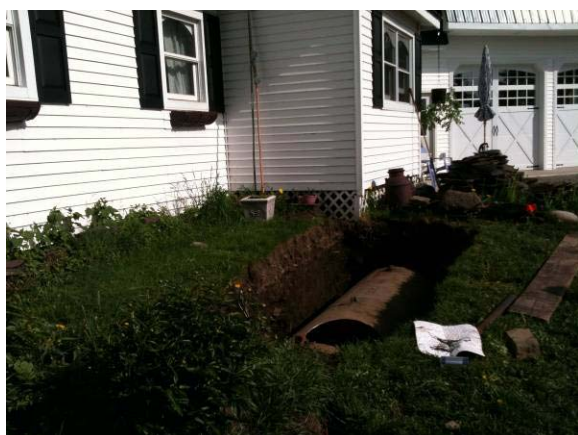
Photograph 5. Location of UST before removal – View toward north.

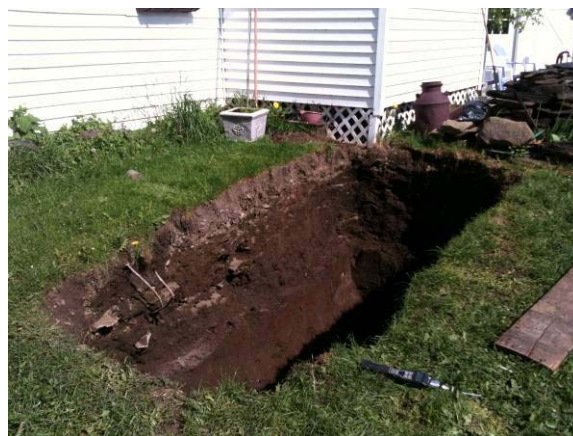
Photograph 6. UST excavation after removal of tank - View toward northwest.

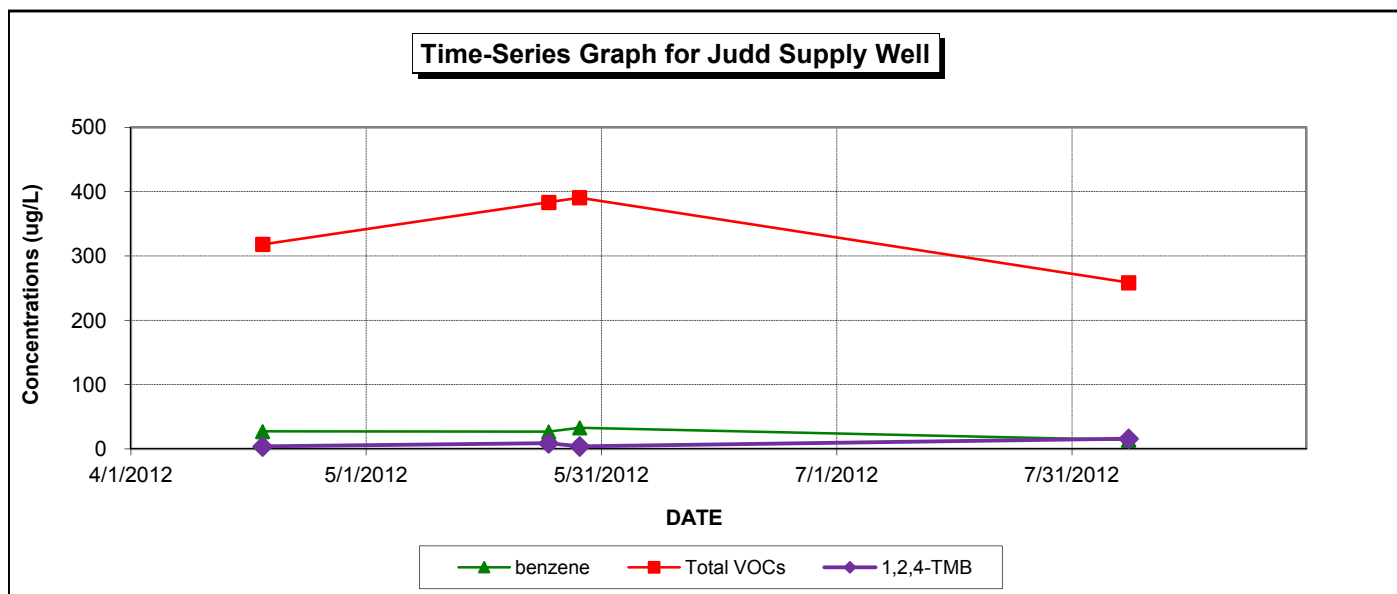
### Summary of Supply Well Analytical Results for Judd Residence

- Benzene was detected in the influent sample collected from the POE treatment system serving the Judd residence at 14 micrograms per liter ( $\mu\text{g/L}$ ), which is above the Vermont Action Level (VAL). 1,2,4-trimethylbenzene and 1,3,5-trimethylbenzene were also detected in the influent sample at concentrations of 16 and 5.7  $\mu\text{g/L}$ , respectively, which exceeds their corresponding Vermont Health Advisories (VHA). Several other petroleum-related compounds were also detected in the influent sample, but at concentrations below the corresponding VALs or VHAs.

On 8 August 2012, three water samples were collected from the POE treatment system. Benzene was detected in the influent sample at 14  $\mu\text{g/L}$ , which is above the Vermont Action Level (VAL). 1,2,4-trimethylbenzene and 1,3,5-trimethylbenzene were also detected in the influent sample at concentrations of 16 and 5.7  $\mu\text{g/L}$ , respectively, which exceeds their corresponding Vermont Health Advisories (VHA). Several other petroleum-related compounds were also detected in the influent sample, but at concentrations below the corresponding VALs or VHAs. No VOCs were detected in the samples collected from the other treatment system samples (between and effluent), indicating that the GAC treatment system is working properly. The analytical results are summarized on the table and time-series graph summarizing the Judd supply well data are included in **Attachment D**.

4. Based on review of the post-installation analytical results, the need for the continued operation of the POE treatment system should be evaluated. If no petroleum contamination is discovered in the new supply well, the use of the POE treatment system should be discontinued and the system should be removed from the Judd property.
